1.0 Bluewater

Bluewater Site Long-Term Custody Compliance Requirements

Bluewater Site Inspection Results

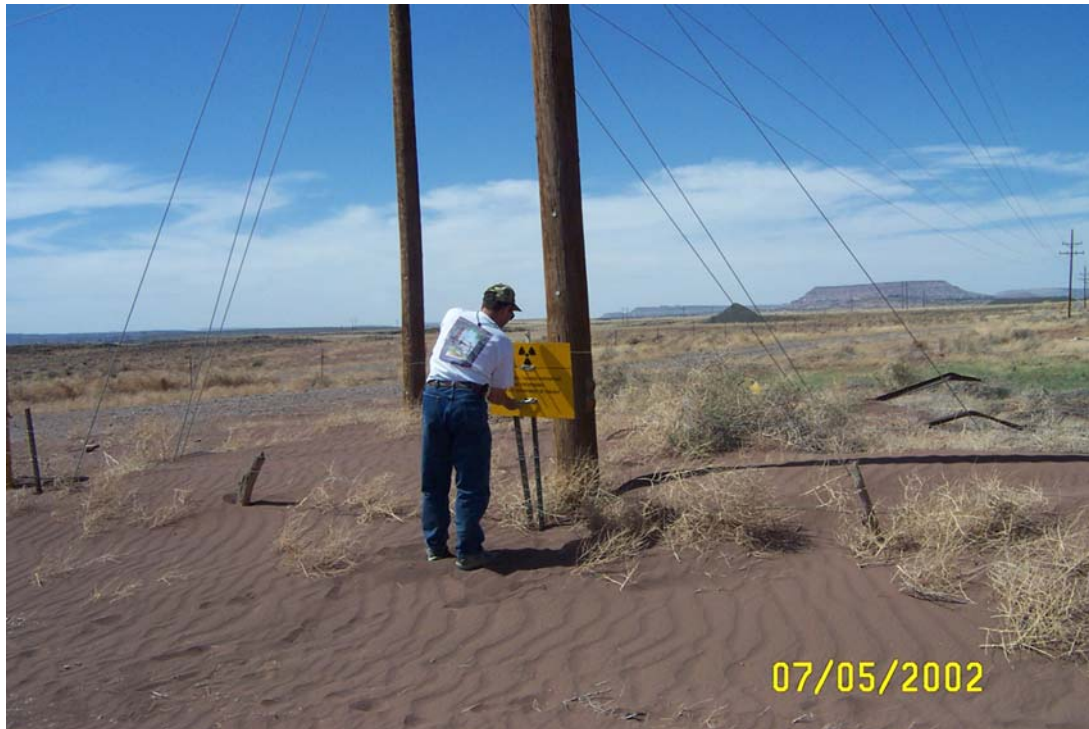
Fifty-four perimeter or warning signs, designated P1 through P52 on Figures 1–1 and 1–2 (including perimeter signs P2A, P2B, P9A, and P9B), are posted at access points along right-of-way intersections with the site boundary and around the main and carbonate tailings disposal cells. At the Bluewater site, all signs are identical and convey the information typically conveyed on entrance signs at other Long-Term Surveillance and Maintenance (LTSM) Program sites. Perimeter sign P1, located at the access gate, was missing; inspectors replaced P1 (PL–1).

BLU 5/2002. PL-1. Replacing sign at entrance gate. (Date shown is incorrect. Actual date is 5/7/2002).

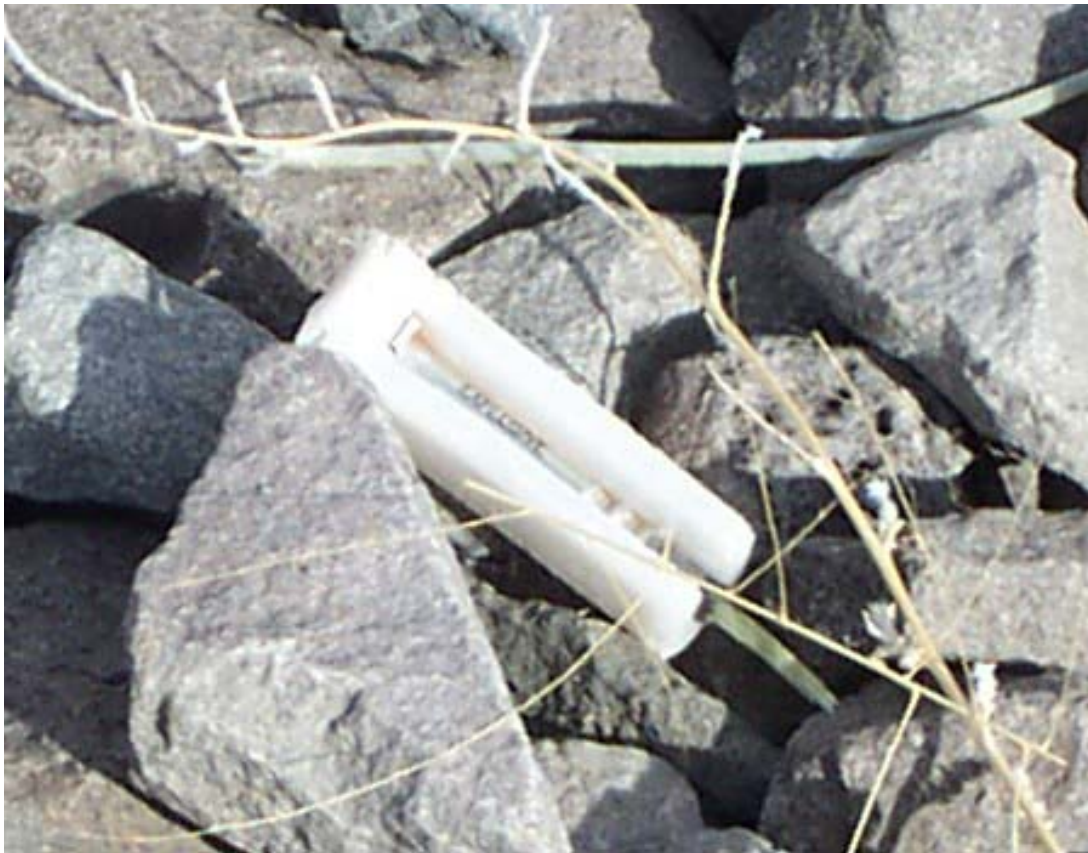
An unexploded blasting cap was found on the northwest edge on the top of the main tailings disposal cell. It was photographed (PL-2) so that inspectors could recognize other potential blasting caps and be cognizant of safety hazards. The blasting cap was not disturbed.

BLU 5/2002. PL-2. Unexploded blasting cap.
